**CORROSION TESTS OF LITHIUM FLUORIDE
IN CONTACT WITH COLUMBIUM ALLOYS**

TOPICAL REPORT II

LITHIUM FLUORIDE BELLOWS CAPSULE TESTS

January 29, 1970

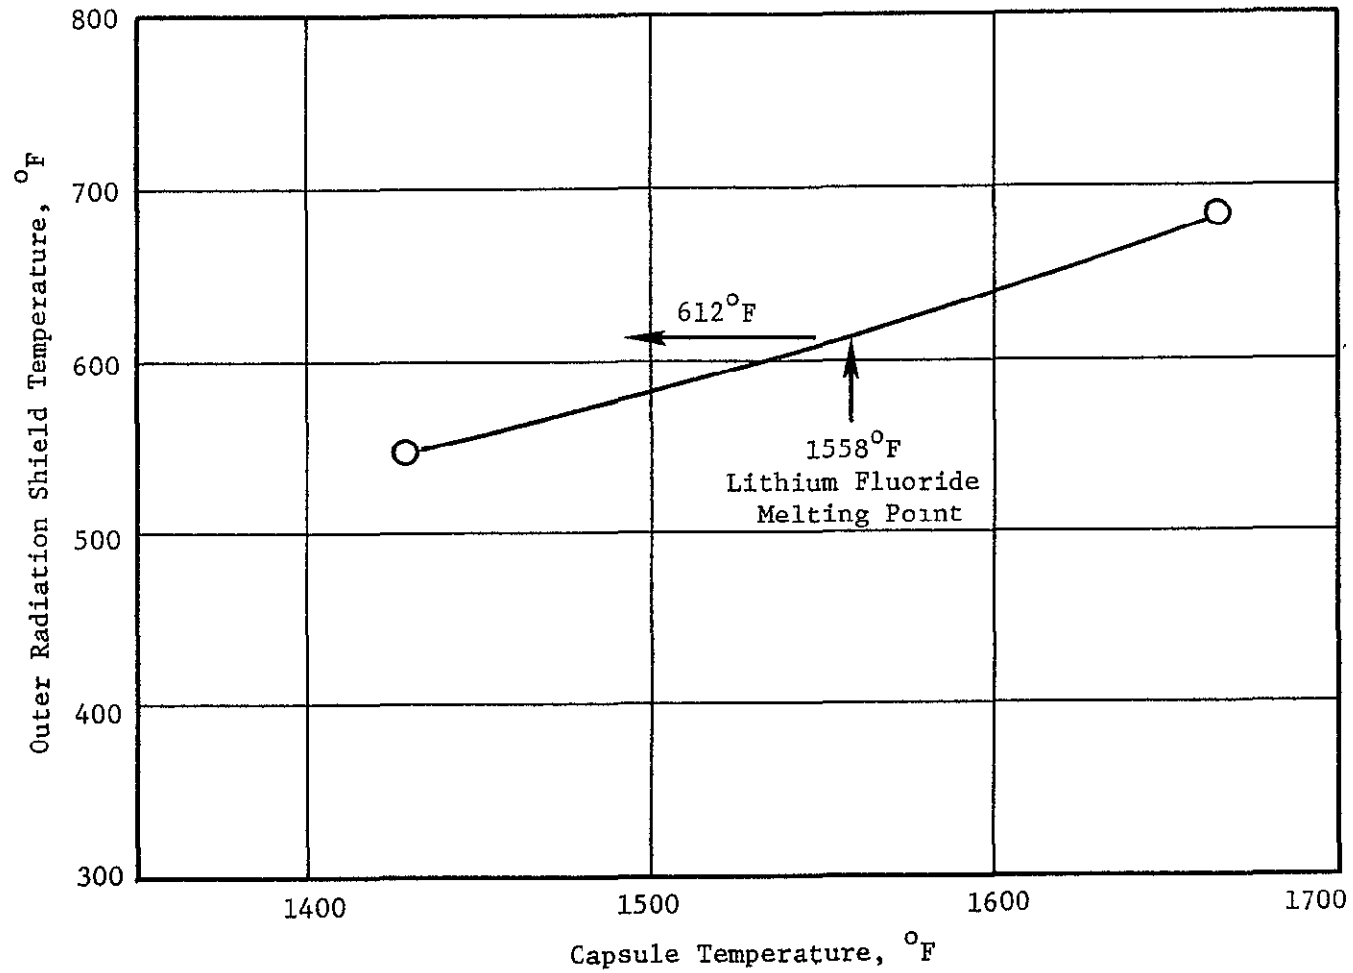
Figure 45. The Steady State Temperature Measurements of Lithium Fluoride Bellows Capsule Test III with 19 SCFM Air Flowing in the Cooling Tube.

From the graph of the capsule temperatures* with air flowing in the cooling tube vs. the outer radiation shield temperature, shown in Figure 45, a shield temperature of 612°F can be found to correspond to a capsule temperature at the melting point of lithium fluoride. From the power temperature curve of the outer radiation shield, shown in Figure 46, a power value of 170 watts can be found to correspond to an outer shield temperature of 612°F. Neglecting small conduction losses, all the heat loss must occur by radiation when no air is flowing in the cooling tube. The power input, when the capsule is at steady state with no air flowing in the cooling tube, can therefore be equilibrated to radiation loss. Using Figures 45 and 46, it may be concluded that the radiative loss is equivalent to 170 watts when the capsule is at 1558°F. Application of 170 watts to the split tantalum heater during the cooling portion of the cycle compensates for this radiation loss. The thermocouples attached to the capsule heater indicate the heater temperature is approximately 10° higher than the capsule temperature during the cooling cycle with 170 watts applied to the split tantalum heater. Under this condition, capsule cooling occurs by heat rejection to the center cooling tube, a better simulation of the heat rejection mode in the proposed Solar Brayton Cycle Heat Receiver.

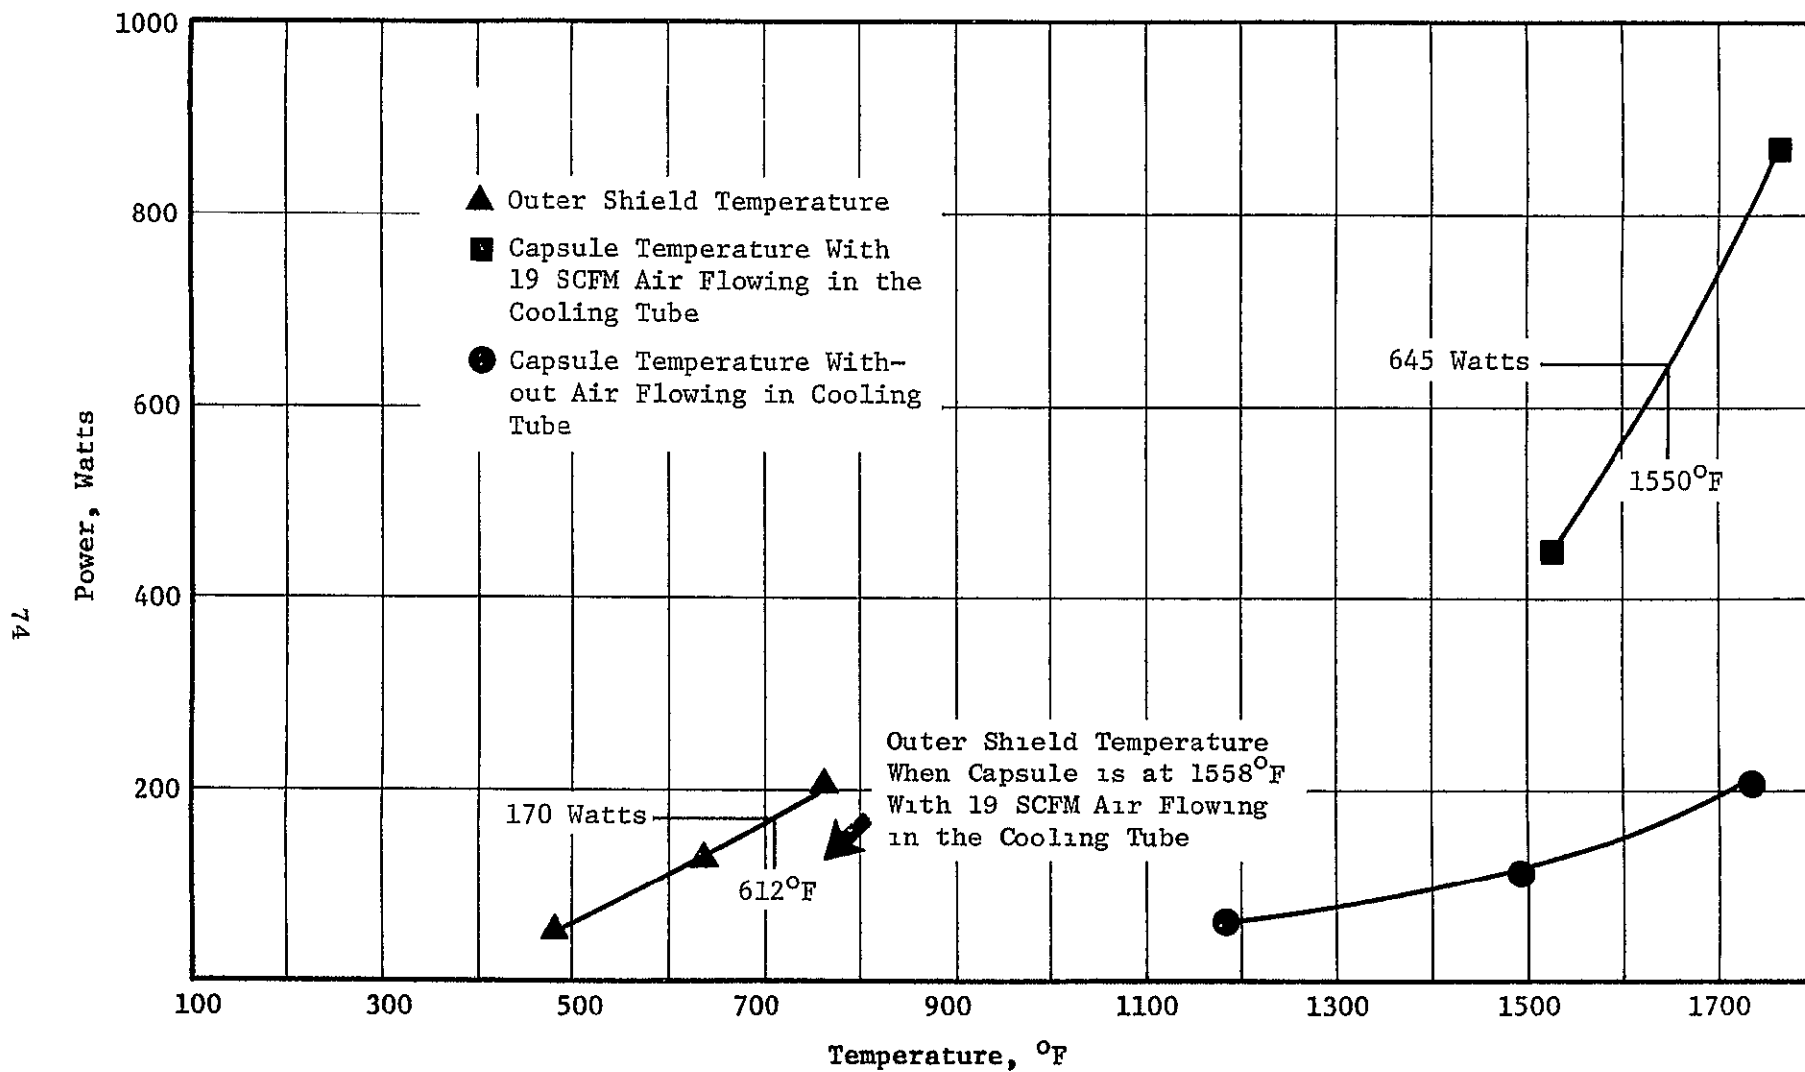
6 Figure 46. The Steady State Temperature Power Measurements of Lithium Fluoride Bellows Capsule III.

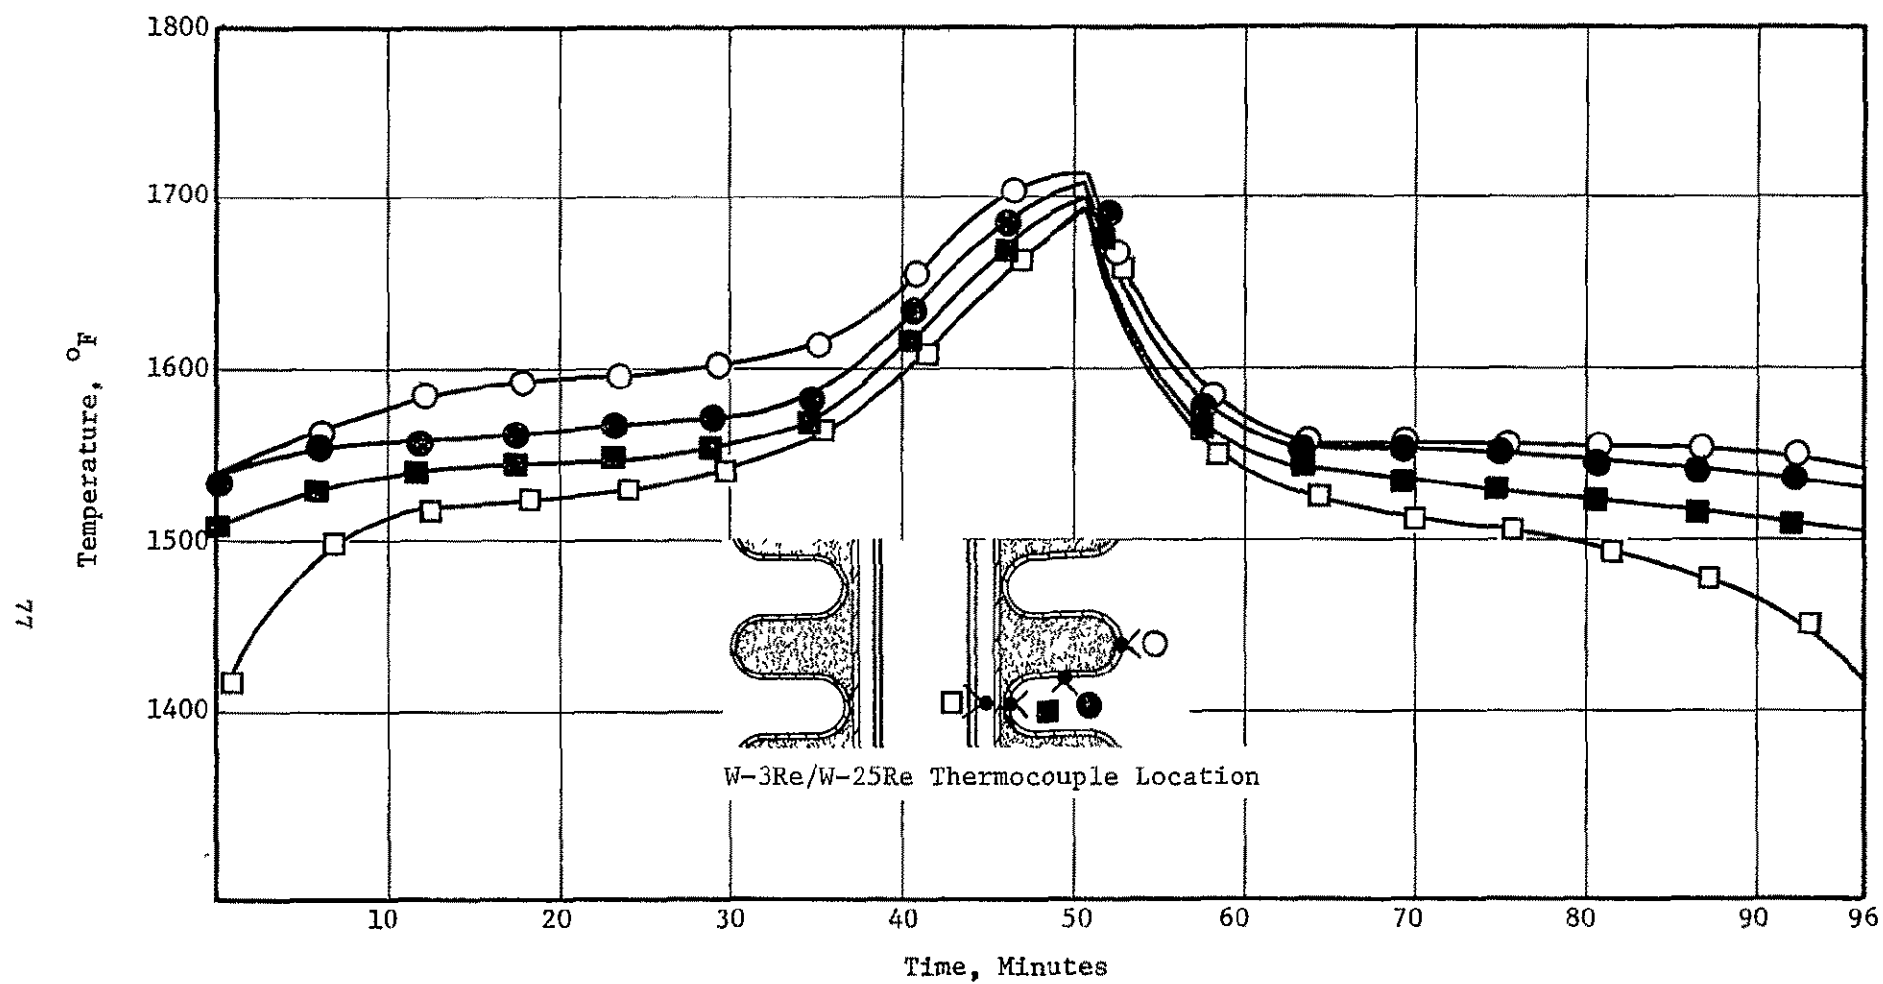
Figure 47. Temperature Profiles on the 88th Cycle of Lithium Fluoride Bellows Capsule Test III.

The operating conditions of a typical cycle are shown in Table XI. The heat balance for the heating and cooling cycles is presented in Table XII. The heating cycle was set by increasing the power above that required to maintain the capsule at 1550°F by approximately 1750 Btu/hr. With this heat input, the lithium fluoride melted and reached a temperature of 1700°F in 51 minutes. The power was reduced at that time to 170 watts, that value previously determined to compensate for radiation losses (Figure 46). The cooling cycle under these conditions is 45 minutes in duration. The temperature profile of the center convolution for a typical cycle is shown in Figure 47.

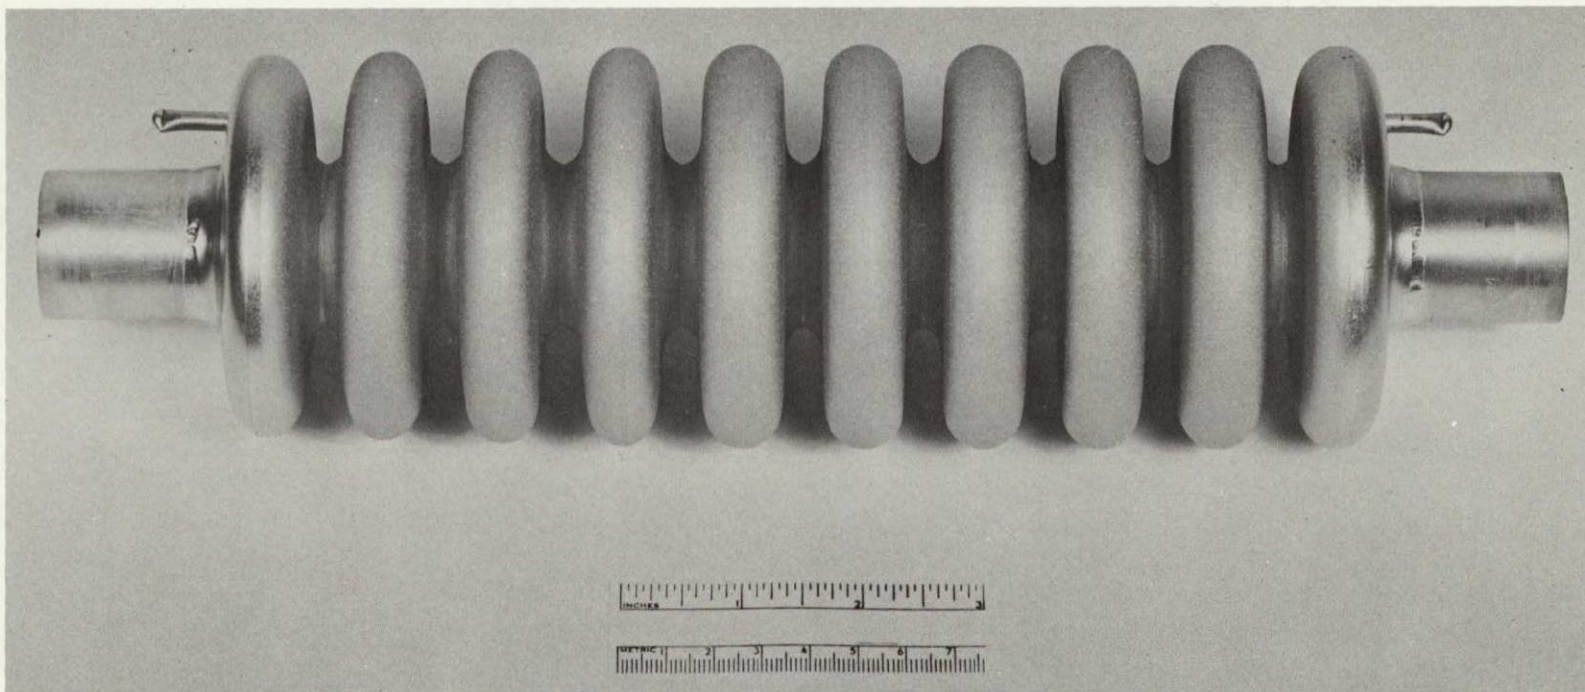
Figure 48. Lithium Fluoride Bellows Capsule III After 5000 Hours Test Time Corresponding to 3125 Thermal Cycles. (P69-10-13A)

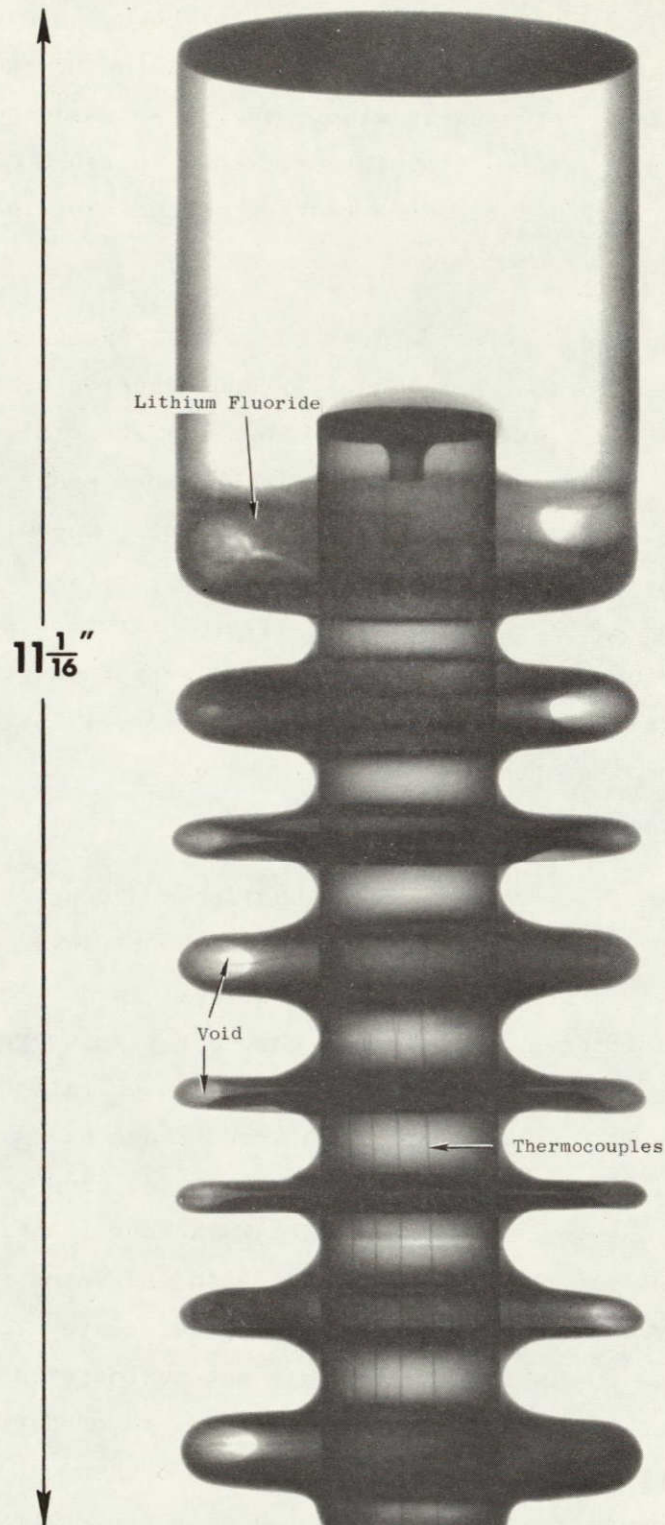
Figure 50. Radiograph of the Bellows Capsule I After 625 Cycles Between 1520°F and 1900°F (1000 Hour Test).

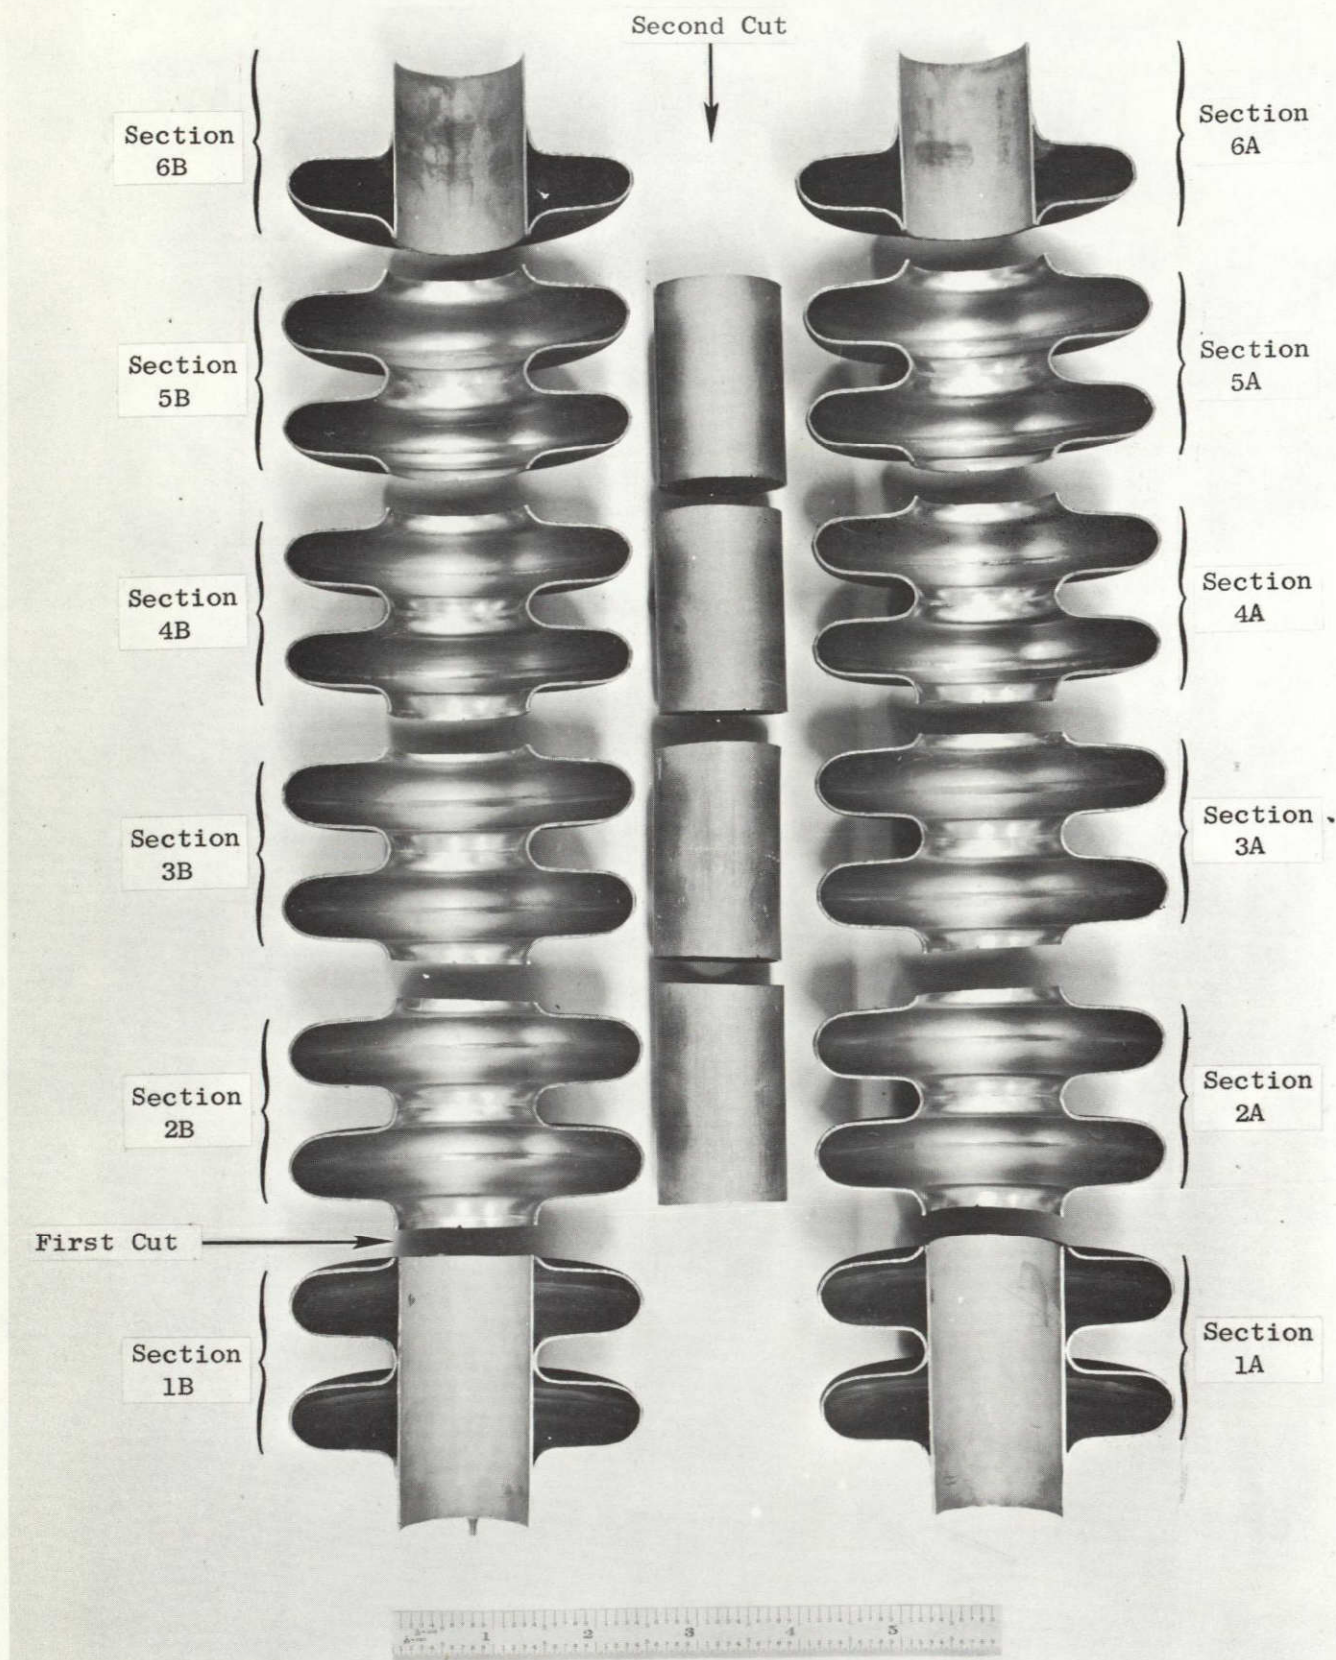
Figure 51. Sectioned Lithium Fluoride Bellows Capsule II After 3000 Hours of Testing and 1875 Thermal Cycles. (C68050714)

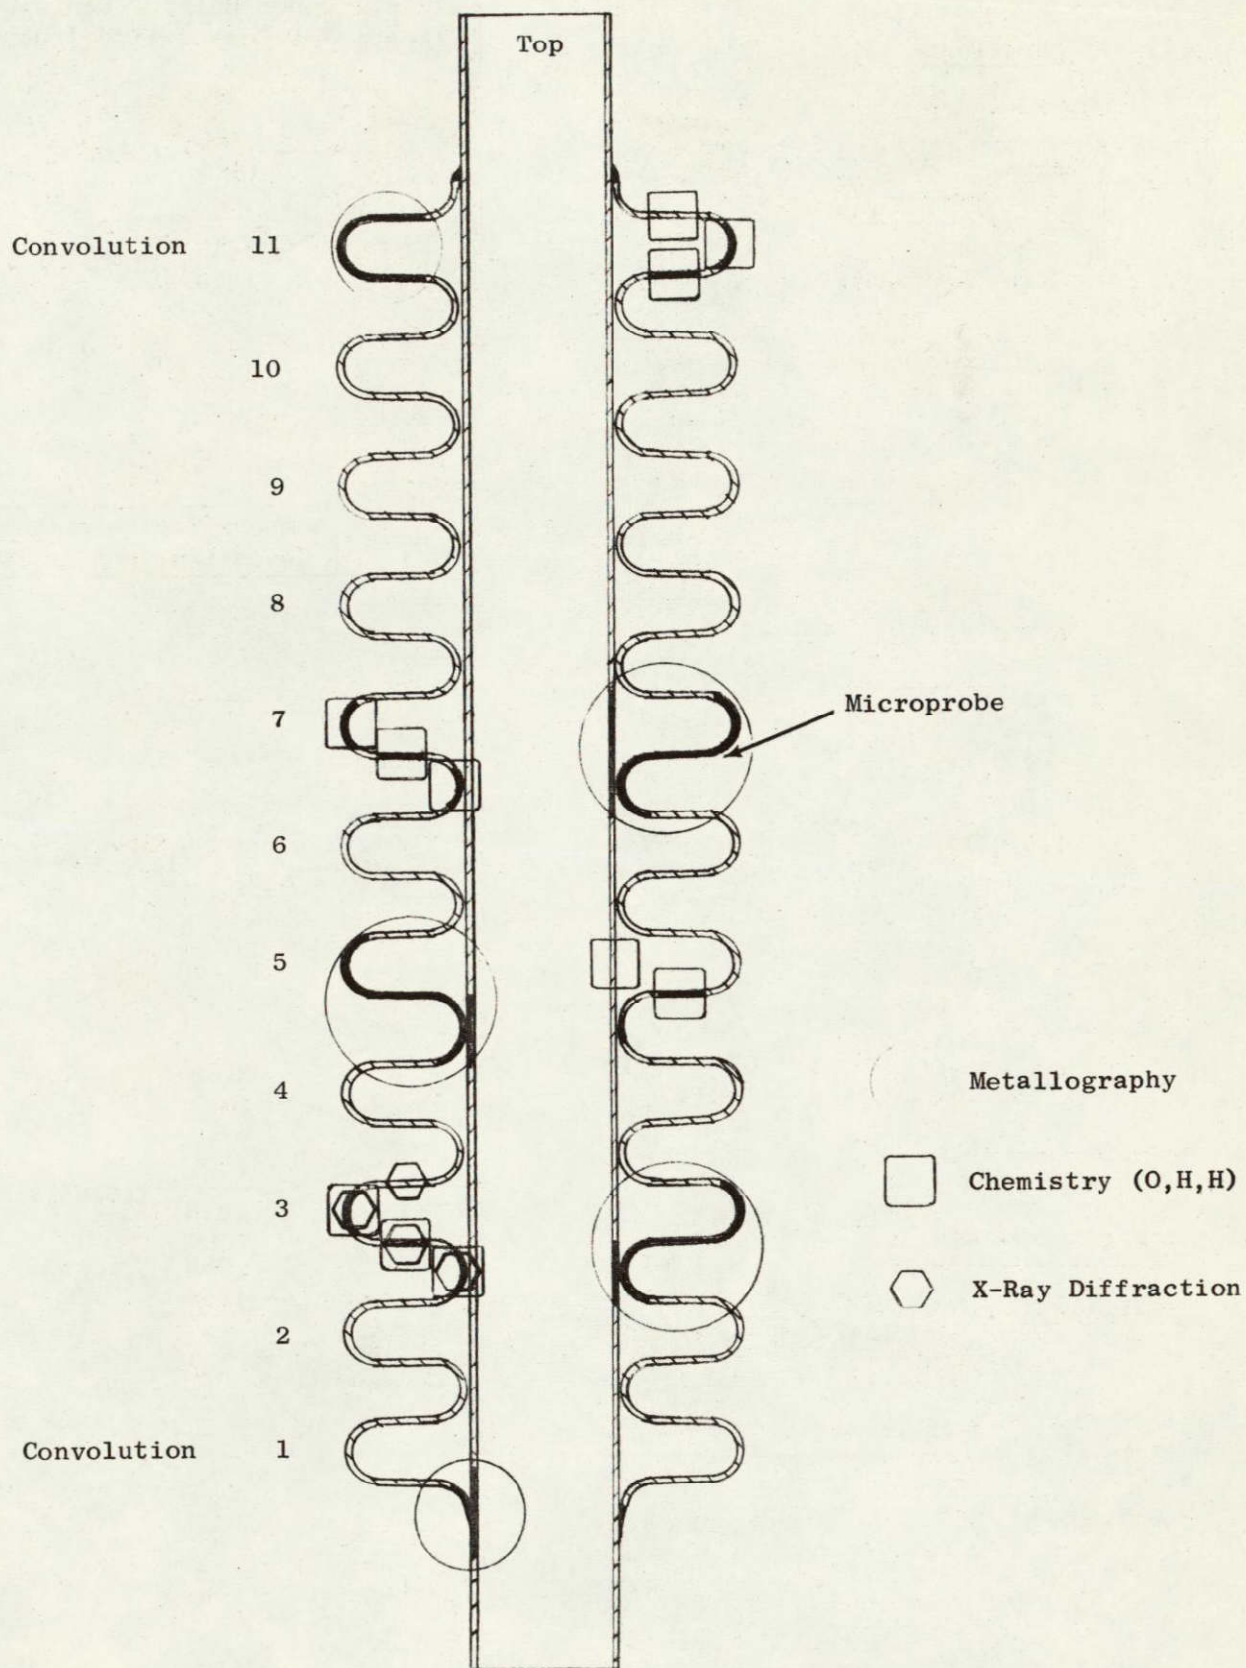
Figure 52. Location of Posttest Evaluation Specimens Taken for Bellows Capsule II.

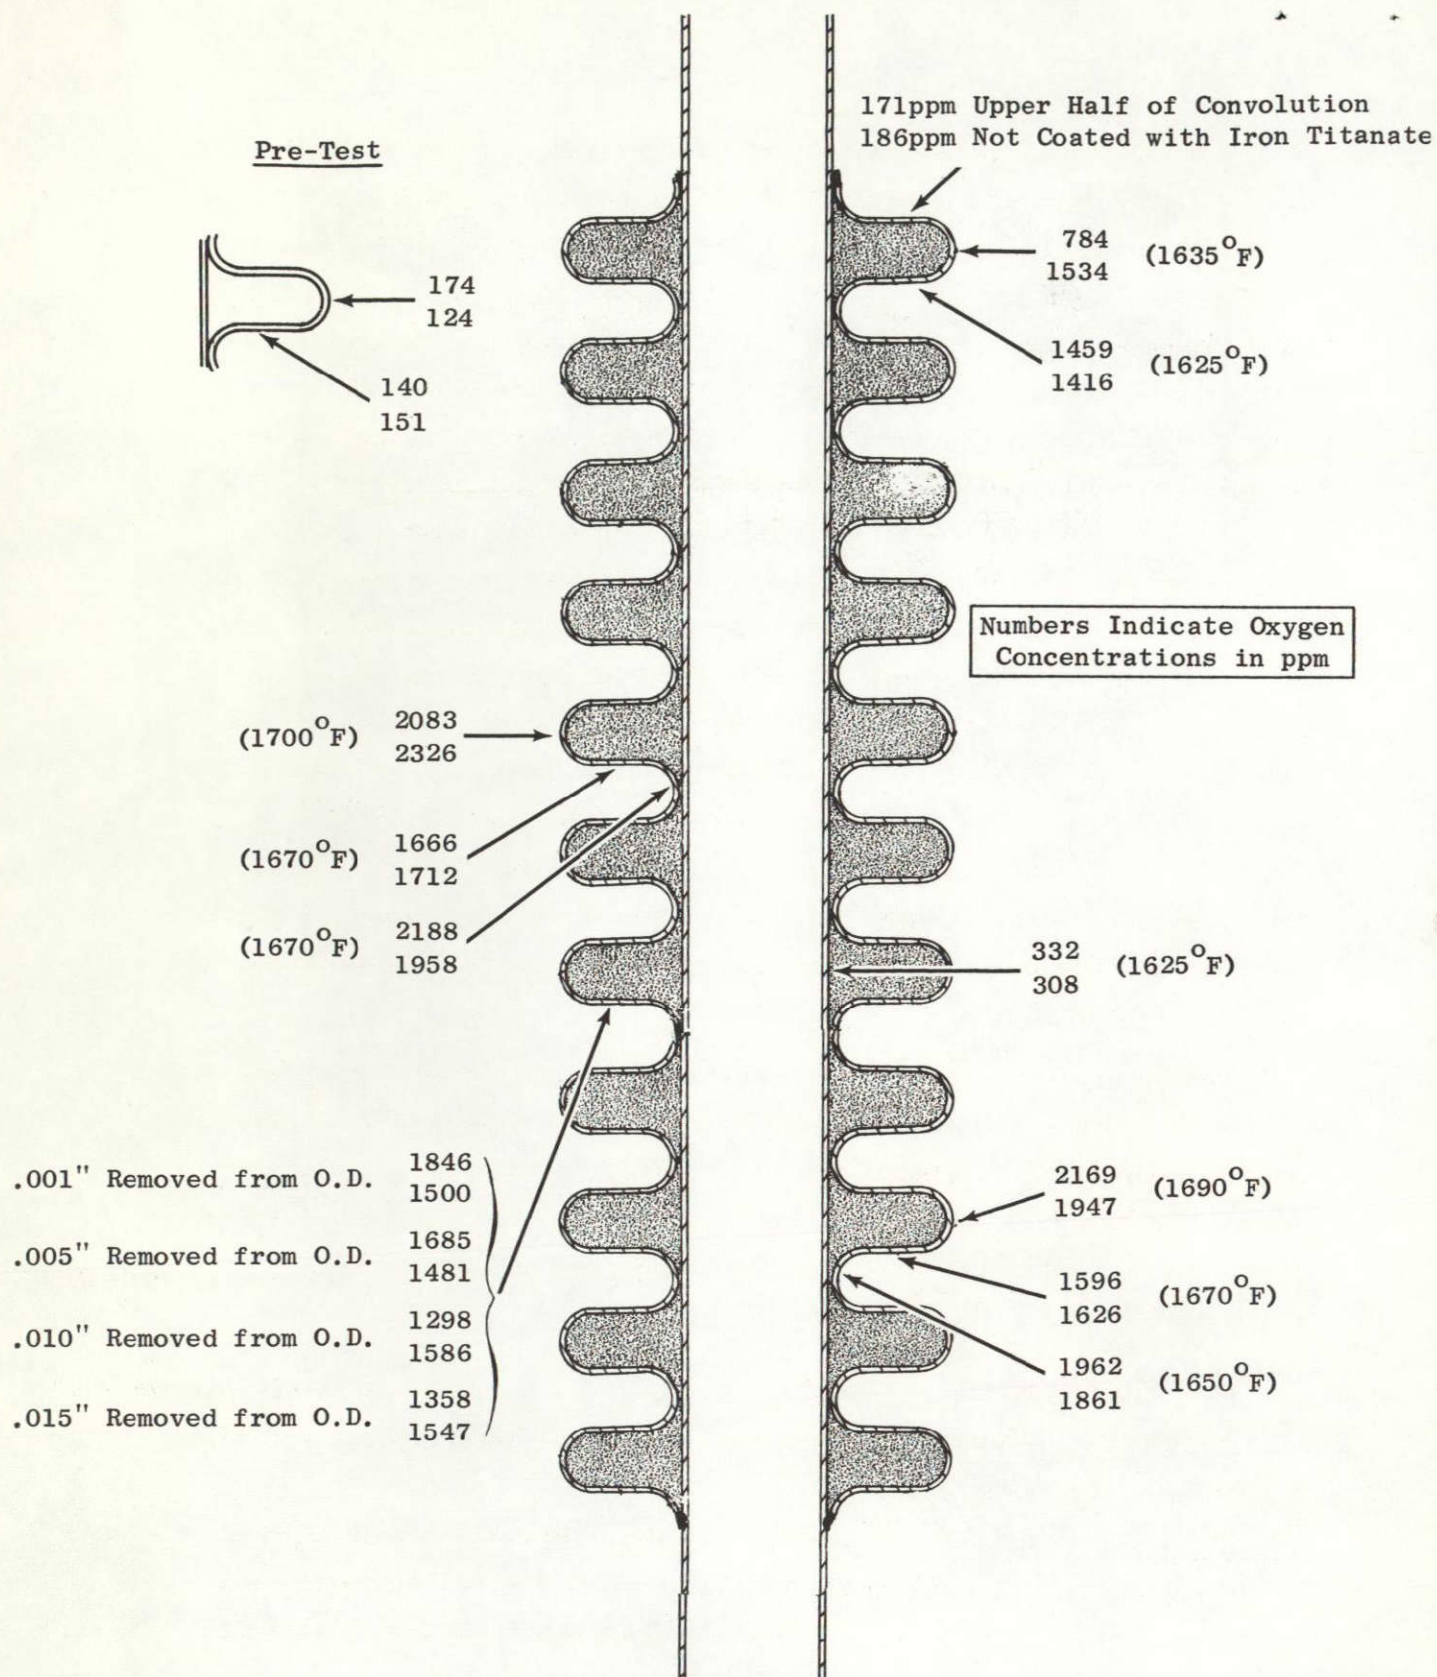
Figure 53. Oxygen Concentrations in the Cb-1Zr of Bellows Capsule II After 3000 Hours of Testing. The Capsule was Cycled Between 1500°F and 1700°F.

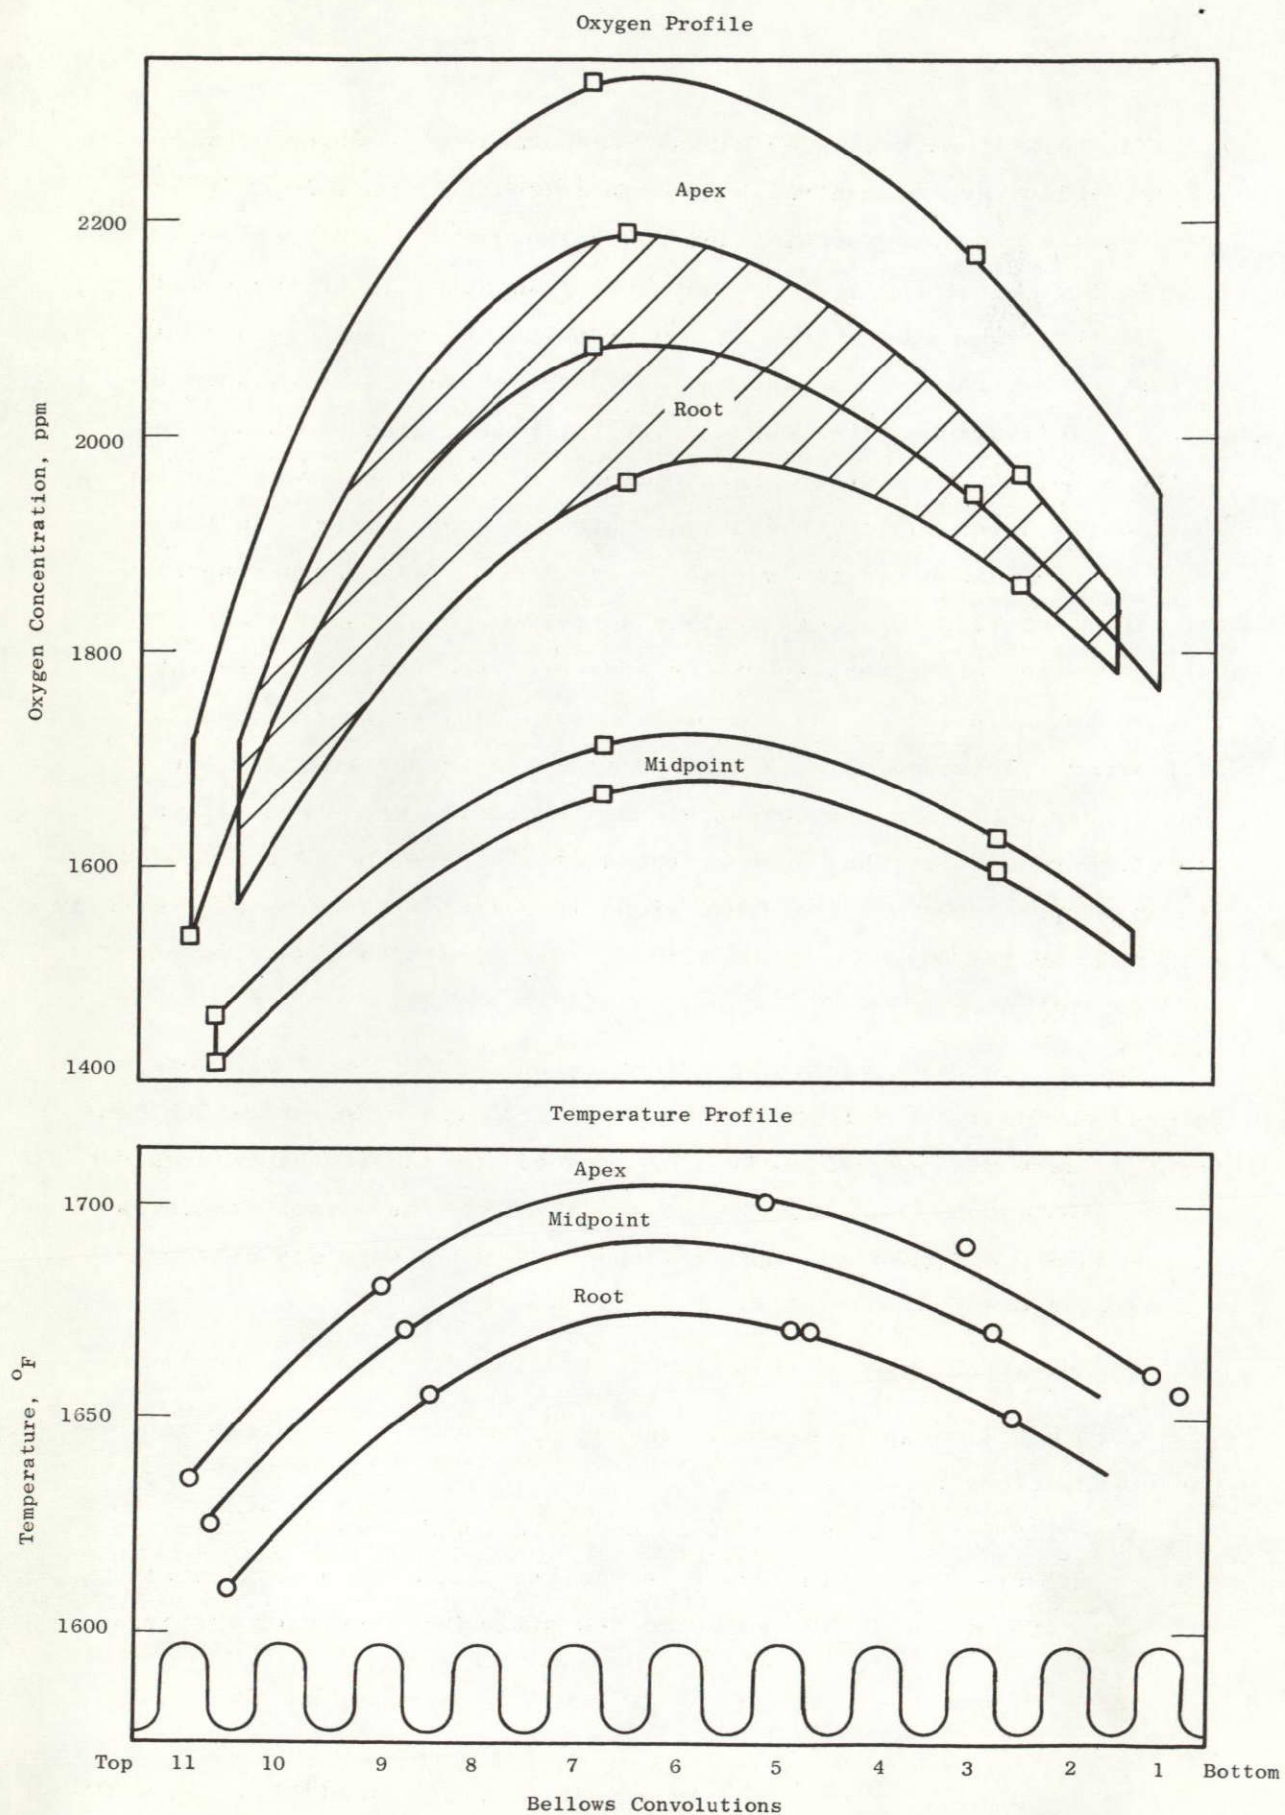
Figure 54. Oxygen Concentration and Temperature Profile of Bellows Capsule II. The Capsule was Cycled Between 1500 and 1700 °F for 3000 Hours.

The relationship between capsule temperature, location of the sample, and oxygen concentration is summarized in Figure 54, which shows the oxygen concentration and temperature profile of Bellows Capsule II. Greater oxygen contamination was noted in the apex and root of the convolutions than in the midpoint areas, even though the temperature at the root of the convolutions was less than at the midpoint. Examination of the capsule after test revealed discoloration in the midpoint convolution areas. Closer examination during sectioning indicated the coating had deteriorated to such a degree in this area that the discoloration was actually the Cb-lZr substrate showing through. Metallographic examination confirmed this observation. Examination of the before test specimens indicated the coating to be very thin in the midpoint of the convolutions as compared to the apex and root areas. This undoubtedly results from the manner in which the coating was applied to the capsule and its complex geometry. It is therefore reasonable that less contamination of the Cb-lZr would occur in the midpoint convolution areas since less iron titanate was originally present, and the oxygen contamination results from the dissociation of the iron titanate.

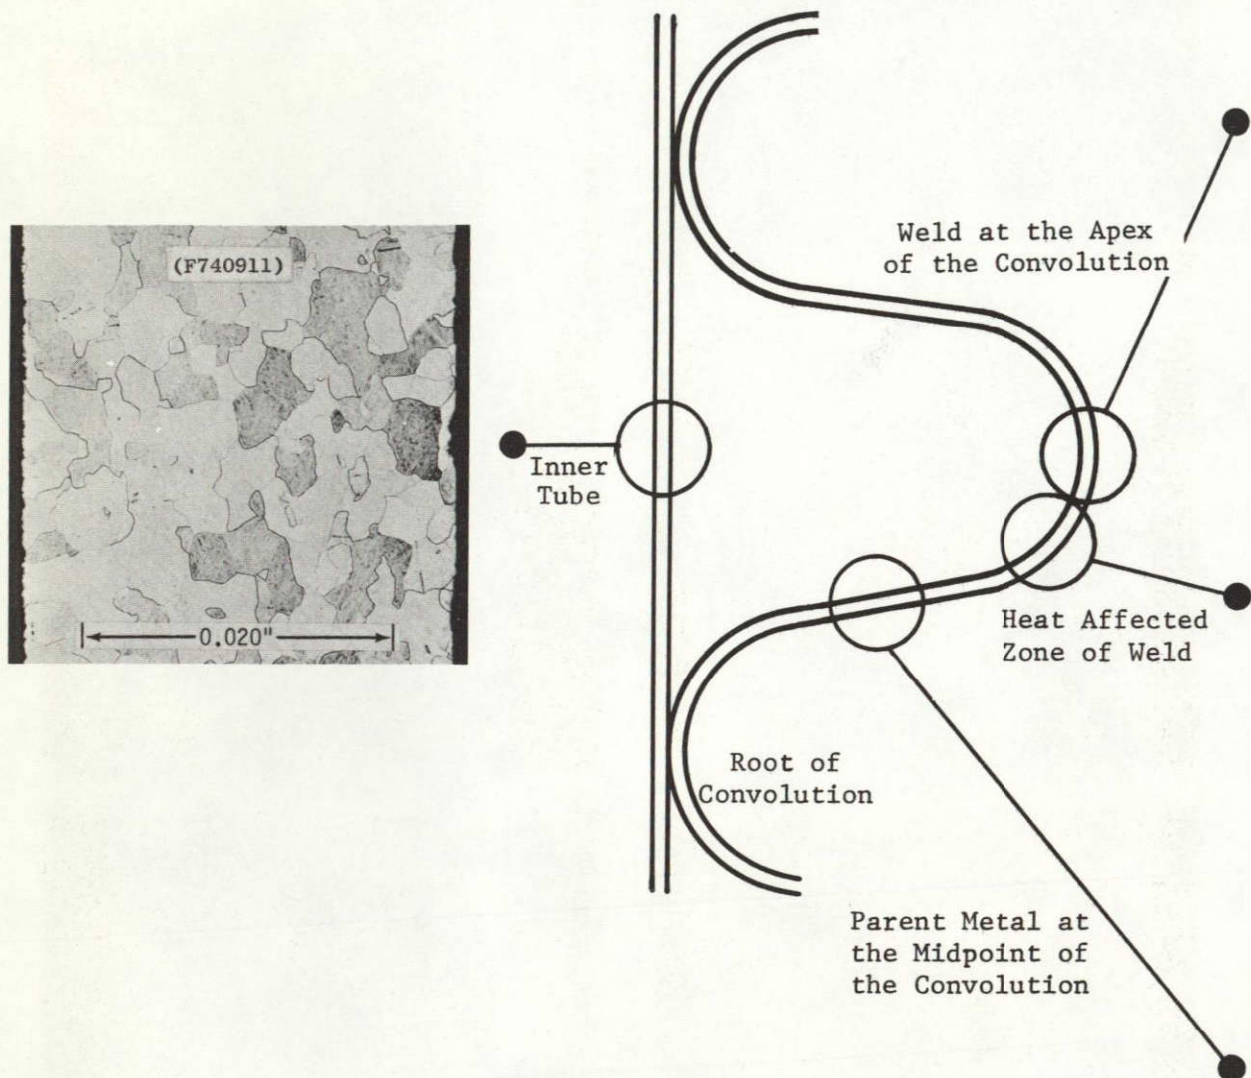
Figure 56. Photomicrographs of Lithium Fluoride Bellows Capsule II. The Cb-1Zr Capsule was Cycled Between 1500 and 1700°F for 3000 Hours Corresponding to 1875 Thermal Cycles.

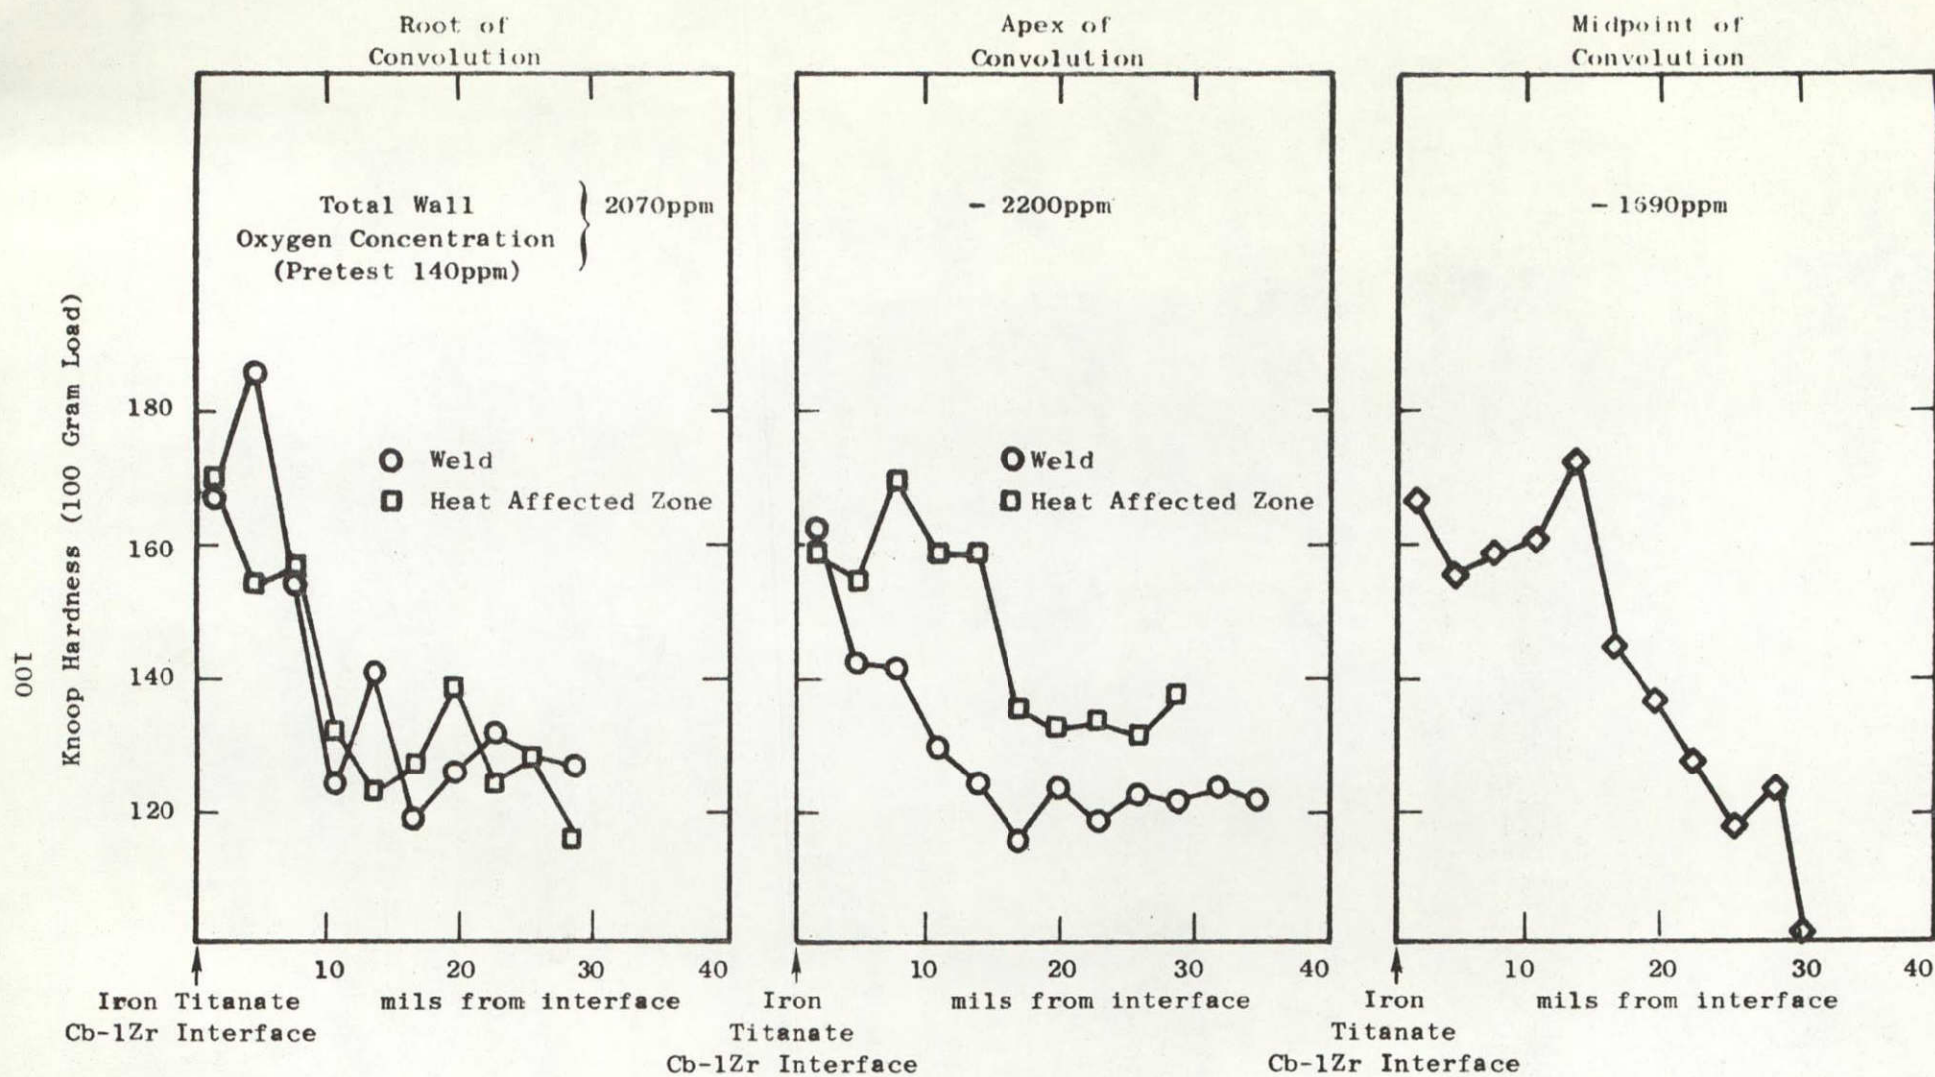
Figure 58. Hardness Surveys of Lithium Fluoride Bellows Capsule II After 3000 Hours of Testing. Pretest Knoop Hardness of the Cb-1Zr was 80.

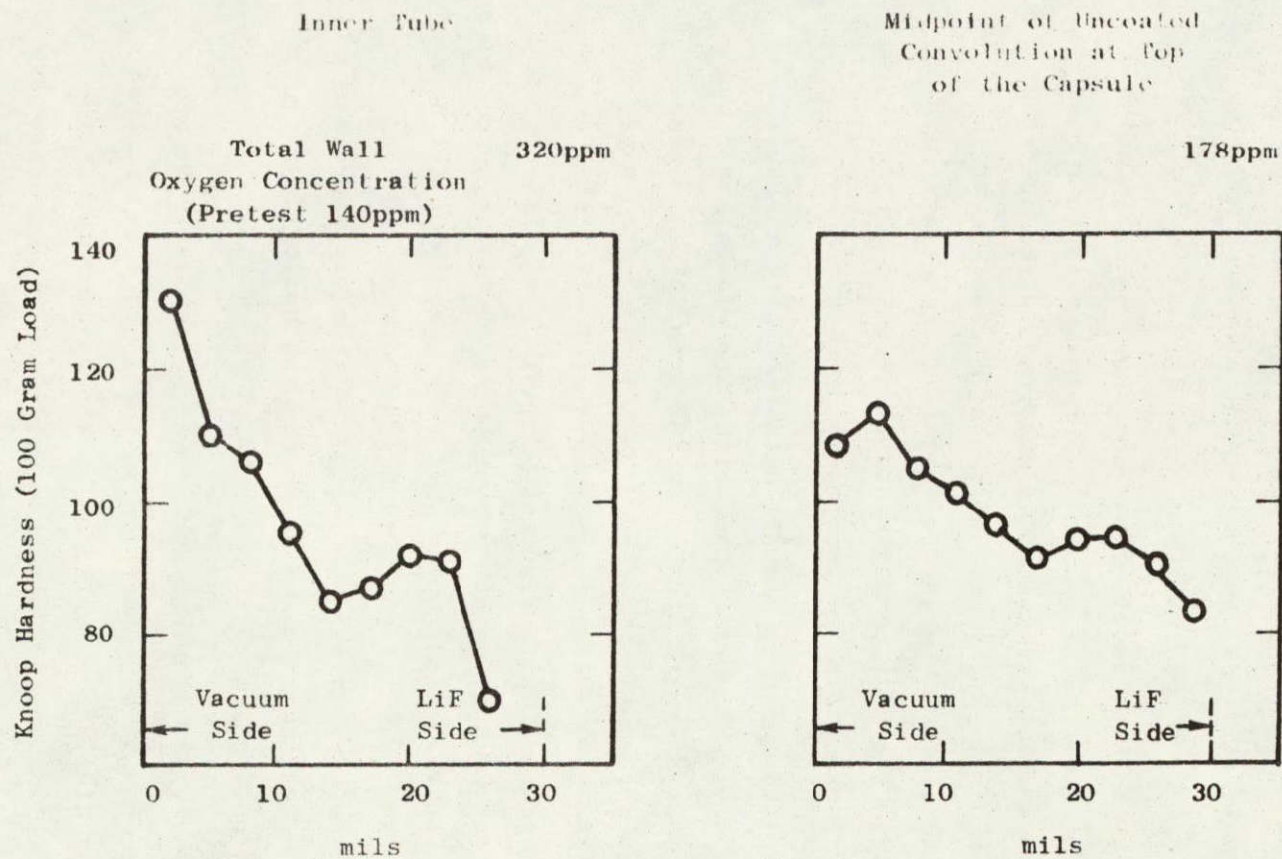
Figure 59. Hardness Surveys of Lithium Fluoride Bellows Capsule II. After 3000 Hours of Testing. Pretest Knoop Hardness of the Cb-1Zr was 80.
